MARYLAND HISTORICAL TRUST
NR-ELIGIBILITY REVIEW FORMNR Eligible: yes
no ☒Property Name: Gaither House Inventory Number: AA-2103Address: Box 182 (Gaither Road) City: Glen Burnie Zip Code: 21060-0182County: Anne Arundel USGS Topographic Map: RelayOwner: Aubrey and Elaine GaitherTax Parcel Number: 592 Tax Map Number: 15 Tax Account ID Number: Acct No. 02011800 Dist. 04, Sub. 000,Project: MD 174 @ I-97 Interchange Reconfiguration Agency: Maryland State Highway AdministrationSite visit by MHT Staff: ☒ No ☐ Yes Name: _____ Date: _____Eligibility recommended _____ Eligibility **not** recommended ☒

MARYLAND HISTORICAL TRUST
NR-ELIBILITY REVIEW FORM

AA-2103

Continuation Sheet No. 1

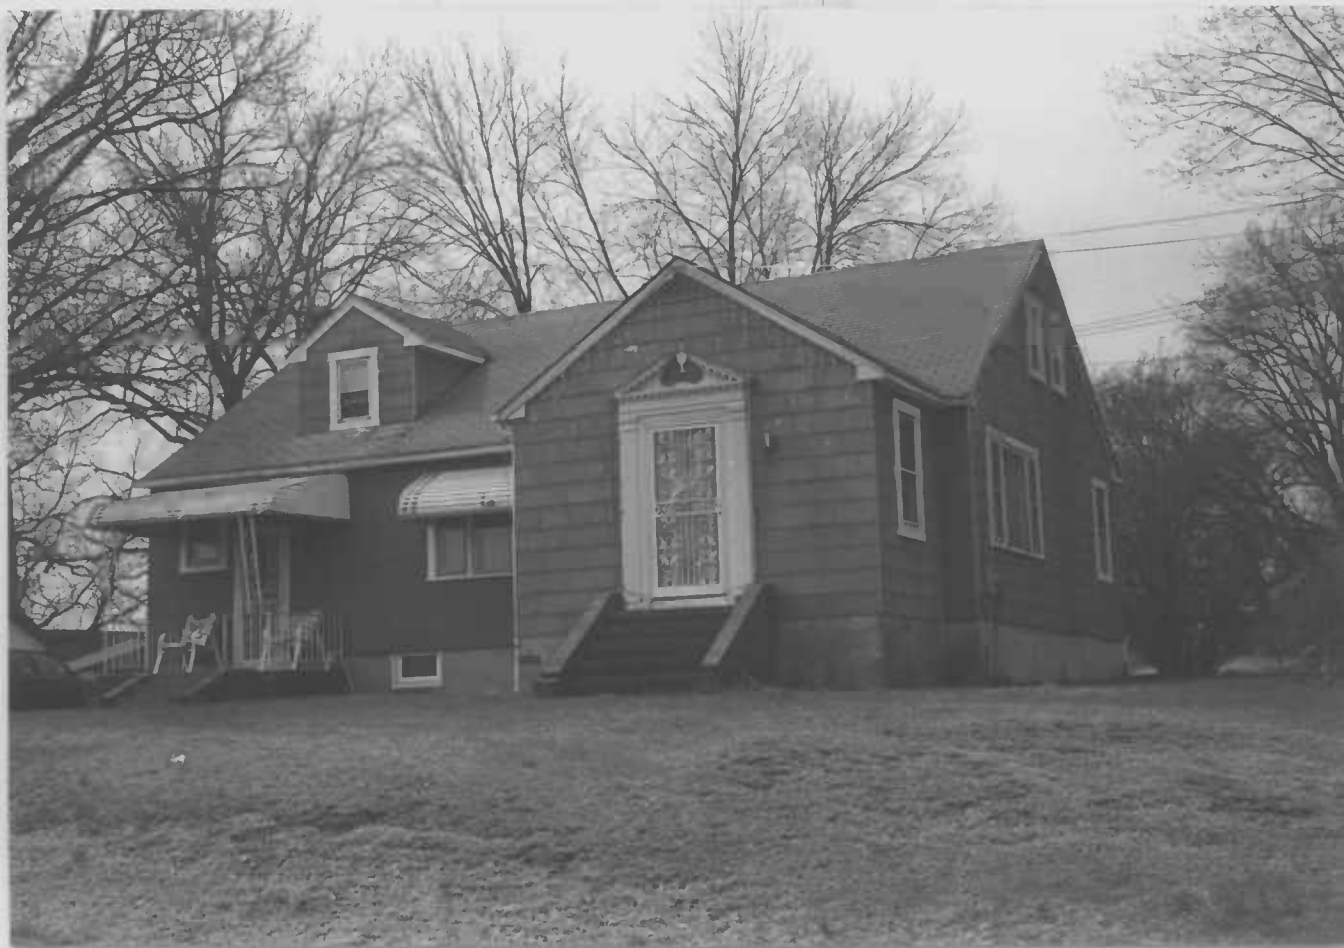
1 of 4

This is a one and one-half story frame residence, located immediately adjacent to the ramp in the southwest quadrant of the MD 174 @I-97 interchange. Gaither Drive is a small side road that follows the curve of the interchange ramp. The house is situated on a knoll, and there are a variety of small and mature trees around the property. This is a gable-and-wing house, and it is clad with asbestos shingles. The house has a concrete foundation and a basement, and asphalt shingles cover the roof. There is a gabled dormer on the main façade, and two gabled dormers on the rear. A chimney rises from the center of the house as well as the exterior, south gable end. There are two entrances on the main façade of the building, each with single-leaf doors. Both have painted iron grilles. The door on the front gable wing also features a fluted wood surround capped with a broken and denticulated pediment, a low brick stairway. There is a small porch at the other front door, with a metal awning and an iron balustrade and support posts. A third door, also with an iron grille, is on the south gable end alongside the exterior chimney. The house has 1/1 and 6/6 double-hung sash-type windows, as well as two five-part picture windows.

View to Southwest showing overview of House
with front entrances + side

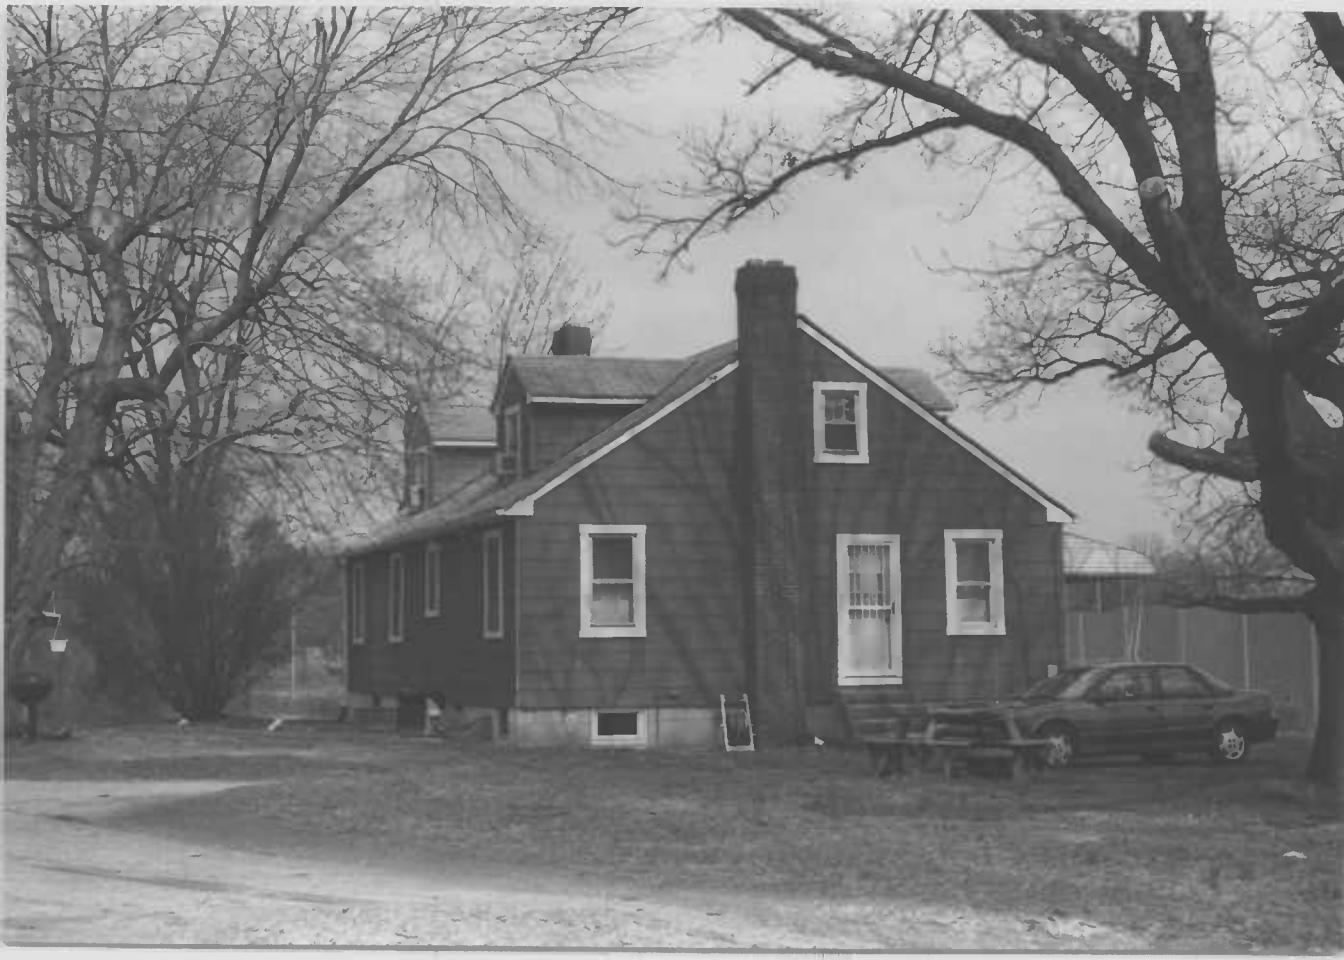
2 of 4

View to north showing side & rear of house

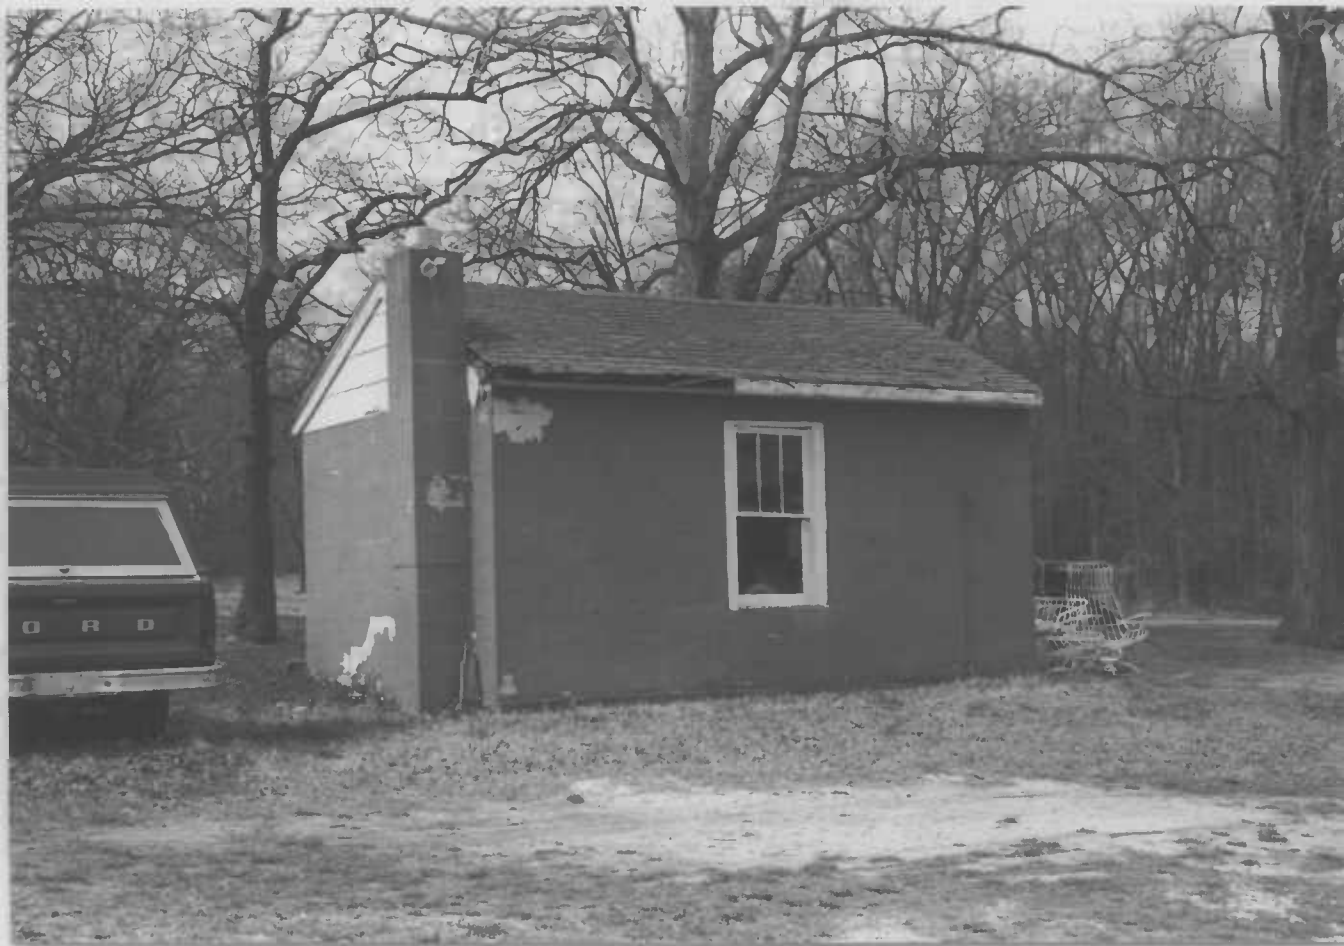
3 of 4

There are two other buildings on the property. The first is a small, rectangular, concrete block structure, single-cell, with a gable roof, 3/1 window on each side, and a gable end chimney. The second is a one-story frame building with gable roof and concrete foundation. The building is sheathed with asphalt shingles, and an interior brick chimney is situated off-center. Most of the windows and other openings, including the door, are boarded up. This building appears to have served as a residence.

View to south of concrete block out building

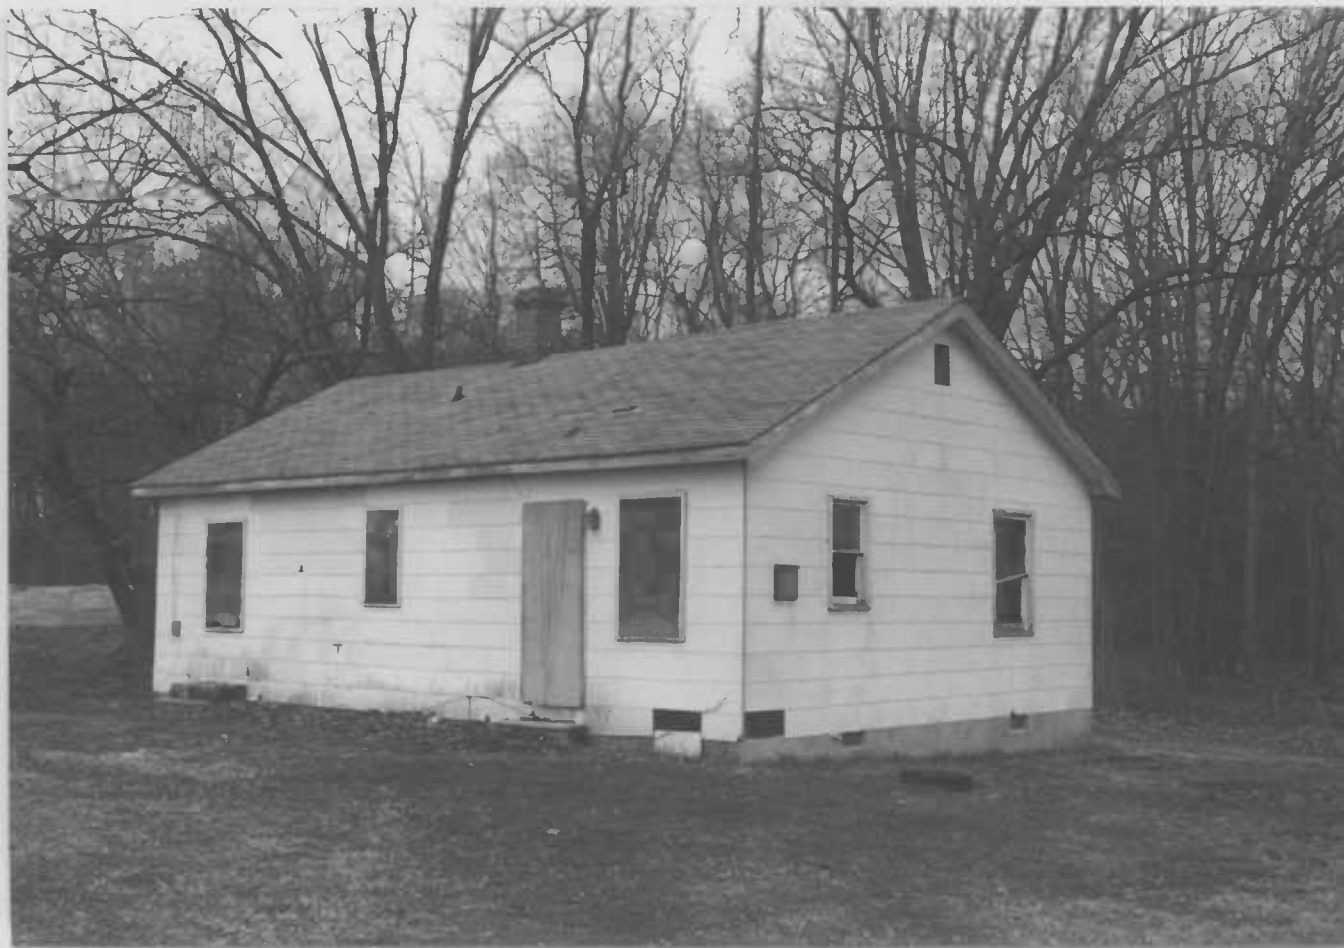
4 of 4

VIEW TO SOUTHWEST, SHOWING FRAME BUILDING
TO SOUTH OF MAIN HOUSE
